HSBC Sustainability Audit Report

March 2006

*Carbon Reduction (CRed) Programme
School of Environmental Sciences
University of East Anglia
Norwich
NR4 & TJ*

Full Report

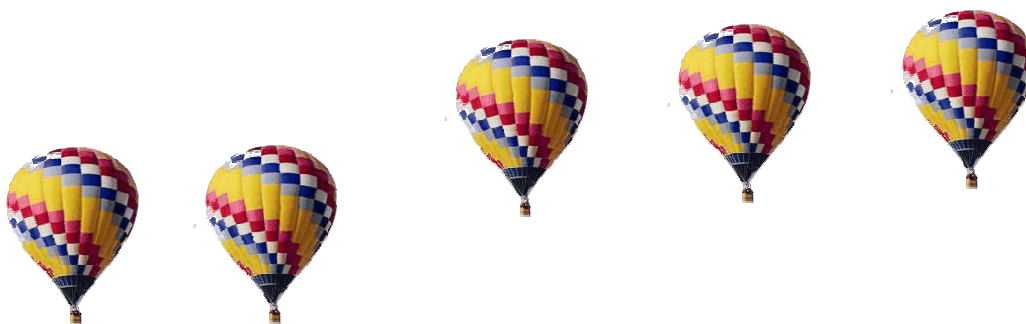
Fig. 6. Schematic representation of the volume of carbon dioxide emitted to sustain the lifestyle of a single person in the UK (2005). By 2050 we must reduce the number of balloons from 5 to 2.

Global warming and Climate Change is one of the biggest challenges facing mankind. Temperatures on the earth have risen around 0.8°C in the last 50 years over the long term average, and are set to rise by at least another 1°C and possibly as much as 5°C by the end of the century. Such rises will bring many consequences ranging from more extreme weather events such as prolonged droughts, increased flooding, and increased incidence of Hurricanes etc. In addition sea level is set to rise. Carbon emissions arise from the use of fossil fuel energy and have caused a rise in atmospheric concentrations from around 320 parts per million about 50 years ago to 380 ppm and it is this that is the trigger for this rise in temperature. It is important to ensure that the need for reducing energy demand is brought to the forefront of the agenda of everyone not only in their homes but in their places of work. Each individual in the UK is responsible, either directly or indirectly, for the emission of 9 tonnes of carbon dioxide per annum. This equates to the volume occupied by 5 hot air balloons and over the next 40 – 50 years it is essential that this emission is reduced by 60% or to 2 hot air balloons per person. Through out this report the symbol of the hot air balloon, as shown below (Fig. 6), will be used as a summary of the situation in each of the branches.

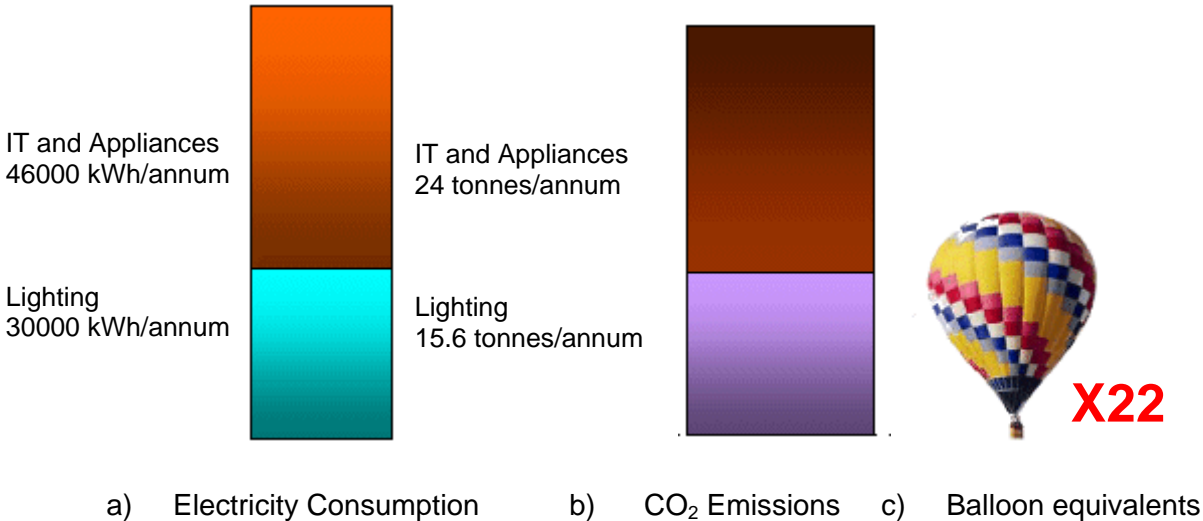
Fig. 7 Estimated electricity and carbon dioxide emissions for the Cambridge Branch for lighting and IT and Appliance use.. NOTE: no meter readings are available so no information on other electricity use or heating is available.

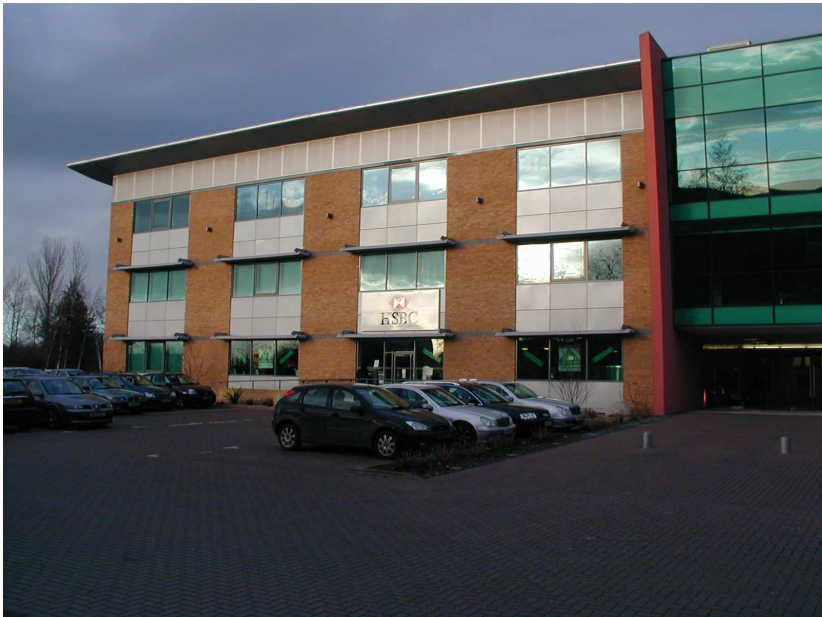
Fig. 8 General View of the southern façade of the building. HSBC occupy the lower two floors. The area to the right is the communal area.

The building is new and is situated in a modern innovation park to the north of Cambridge which adjoins the A14 Trunk Route (Figs. 8 and 9). HSBC occupy two floors and rents the accommodation from a landlord. The ground floor is the retail area focused primarily on business customers. The first floor is an open plan office area. The eastern end of the building is a communal area containing stairs and access to the top floor where a separate tenant has offices.

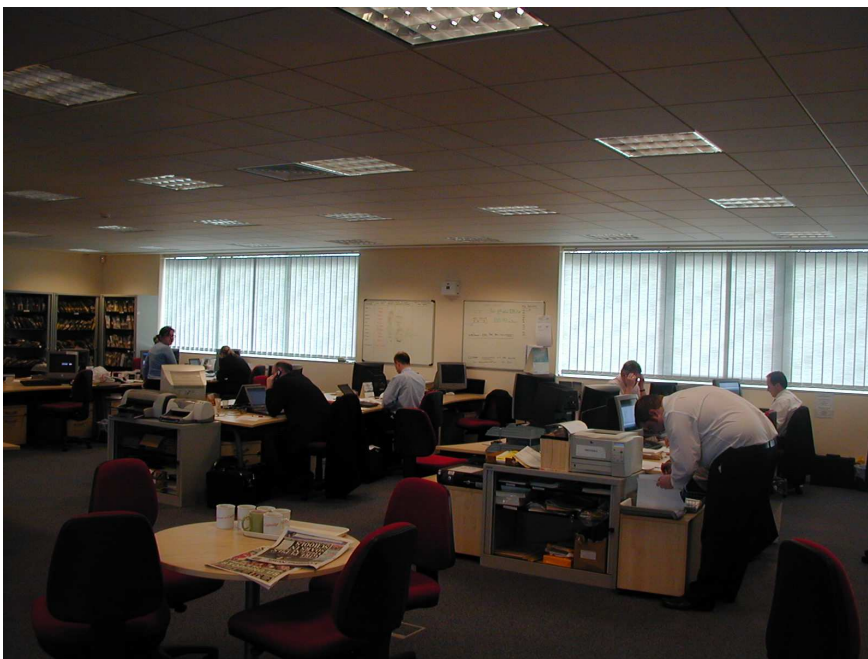
Fig. 12. The south side of the first floor. The blinds are drawn to prevent glare but all lights are on the south side. Several staff were wearing short-sleeved shirts.

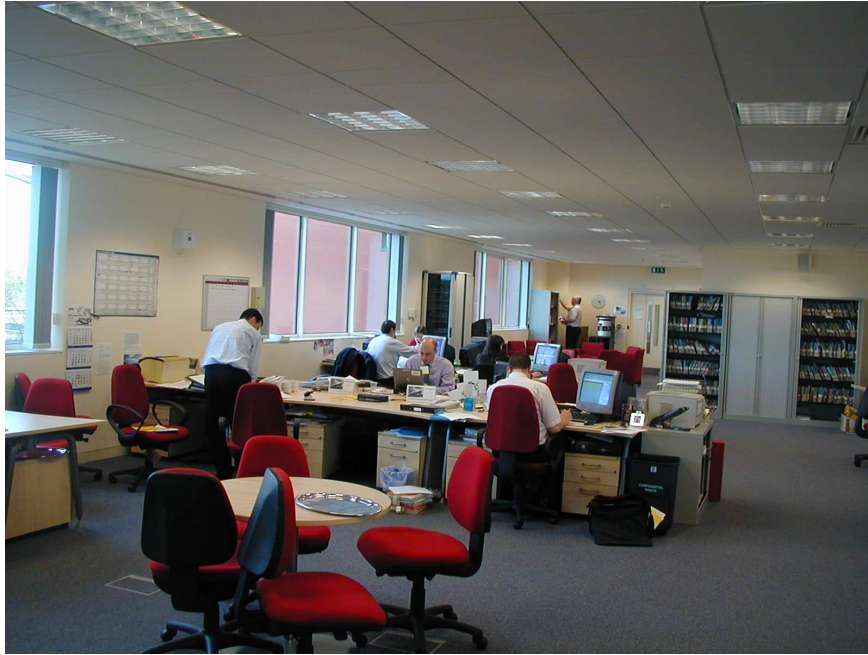
Fig. 13. The north side of same office. Once again short-sleeved shirts are in evidence.

The first floor is largely an open plan office stretching the full width of the building (from south to north) as shown in Figs. 12, 13 and 14.

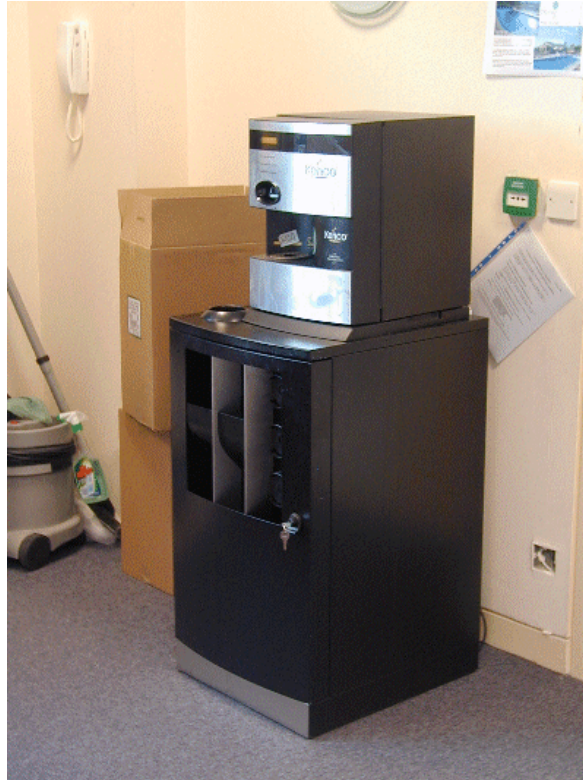
In addition to the kitchen on the ground floor there is also a coffee machine in the first floor office (Fig. 15). The casing of this appeared to be quite hot indicating a high heat loss (unlike the coffee machines in Norwich which were quite cool to touch).

Fig. 15. The first floor coffee machine. The outer surfaces of this machine were quite hot on the day of the visit.

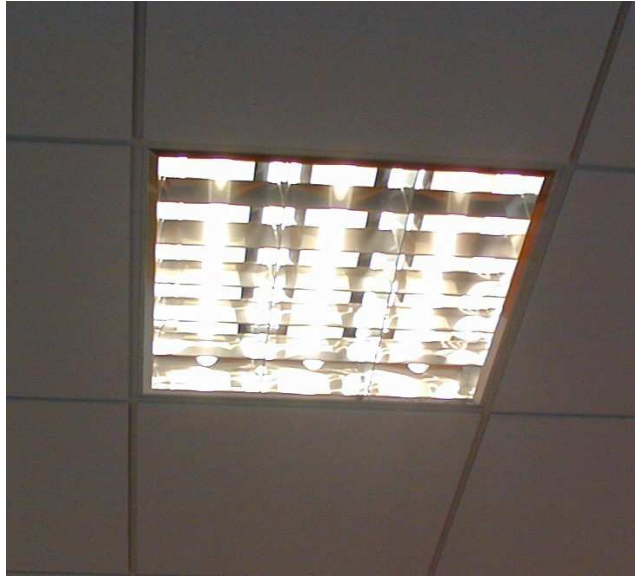
Most of the lighting is provided by banks of 3 x 2 ft fluorescent tubes which have reflectors (Fig. 9). All lamps were working. The total number of light fittings of this type on the floor is approximately 60 representing a total wattage of approximately 3.3 kW, and a daily consumption of 35 kWh. In addition there are smaller numbers of Compact Fluorescent Lamp (CFL) units, seven 50W spot lights over the Cash Points and 6 larger spots (see Fig. 3). Finally there are two 50 W display spots in the conference room. These additional lights increase the daily total electricity consumption on this floor to about 48 kWh per day

Fig. 16. Typical lighting fitting on both ground and first floors

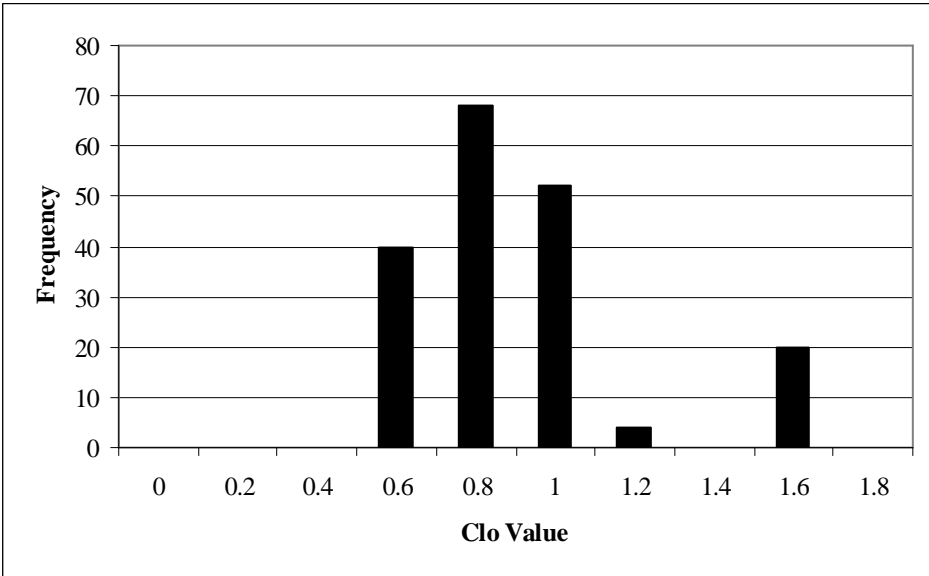
Though the mean clothing level was 0.82, 27% of respondents were wearing clothes with a clo value of 0.55 corresponding to the short sleeves noted at the time of the visit, and a further 44% were wearing clothing with a clo value of 0.65. The mean value is affected by one person wearing clothing to a level of 1.6. Interestingly, this person still indicated that he/she was slightly cool voting -1 on all occasions. The data relating to the clo value is shown in Fig. 17.

Fig. 17. Clothing levels of staff in Cambridge Office.

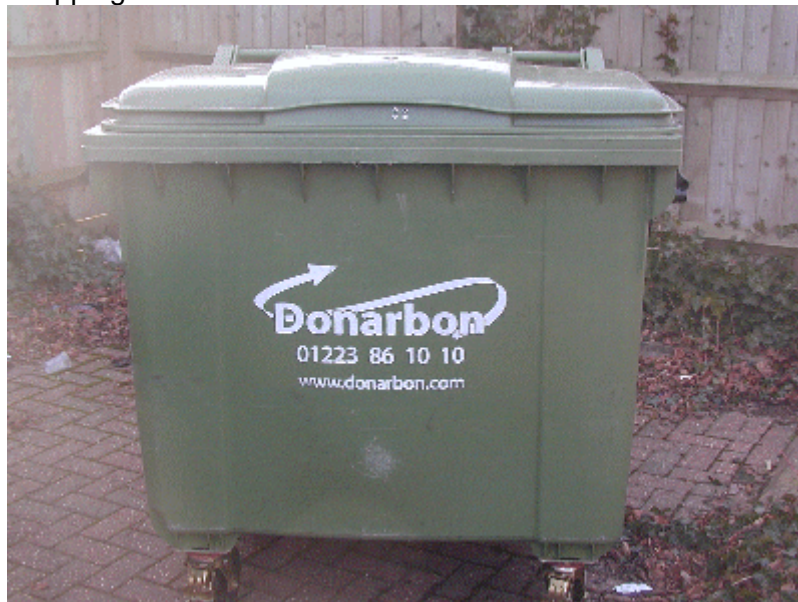
Fig. 18 The waste bin which is locked preventing cross contamination of waste

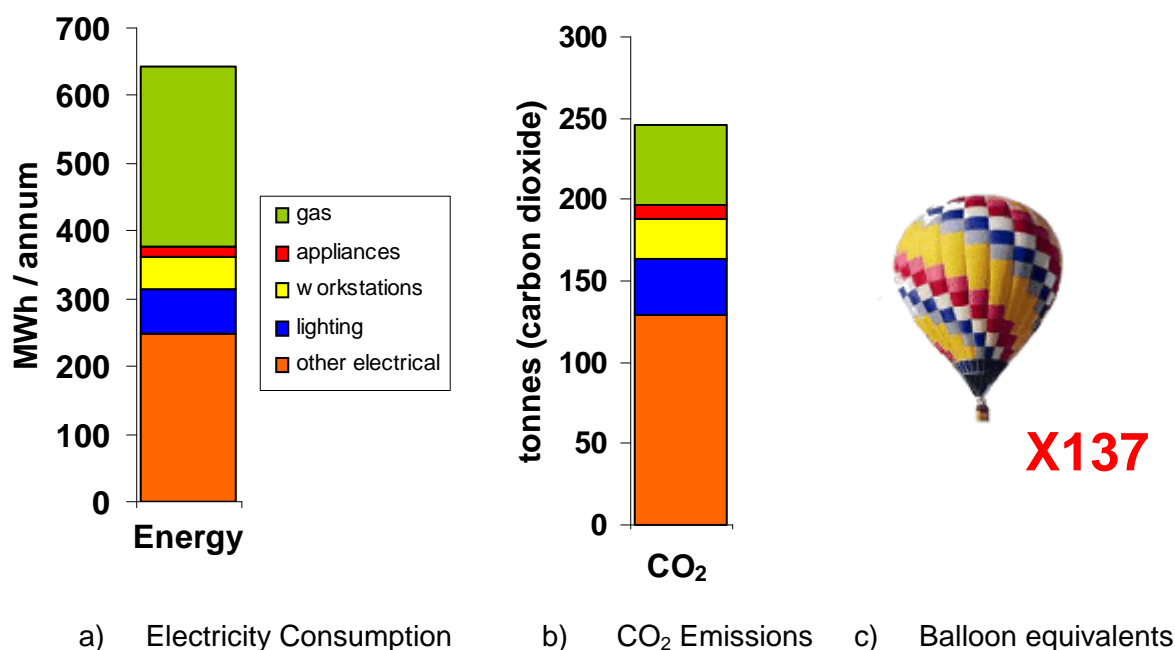
Fig. 19 Estimated electricity and carbon dioxide emissions for the Norwich Branch.

What is particularly surprising from Fig. 19 is the fact that total gas consumption is only two thirds of the consumption of electricity, and that the total estimates of identifiable electrical appliances only account for approximately one third of total electricity consumption. Normally this figure is much higher and almost double that figure in the other branches for which there are data. The other uses of electricity are particularly high and are almost certainly associated with supplementary heating and air-conditioning. Space heating provided by electricity is not only more costly than heating by gas, but also the carbon emissions are significantly higher with electricity.

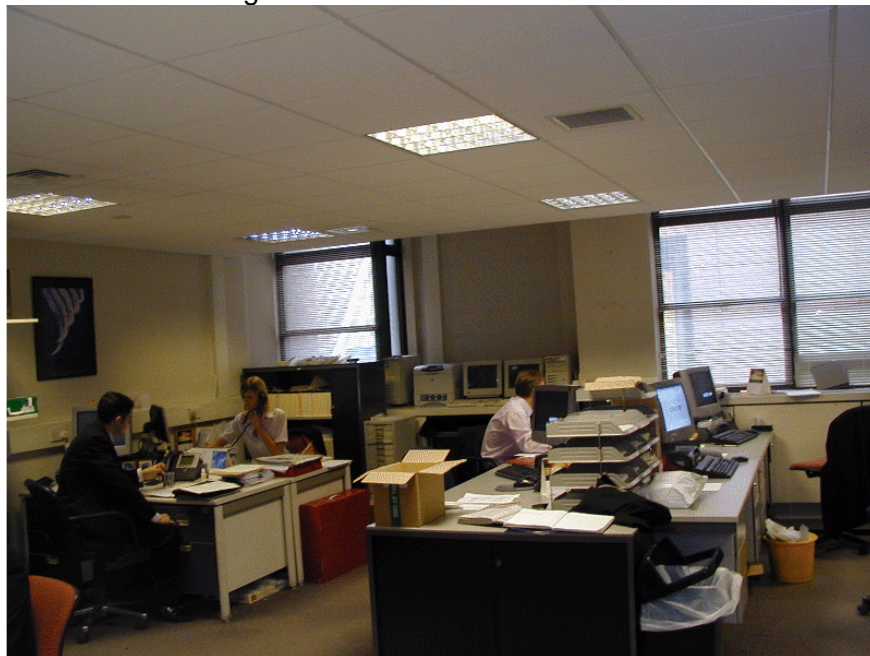
Fig. 22. First Floor Office. There is limited natural daylight in this office. This office is reputed to be the hottest of all – one member of staff has short sleeve top suggesting this is indeed the case.

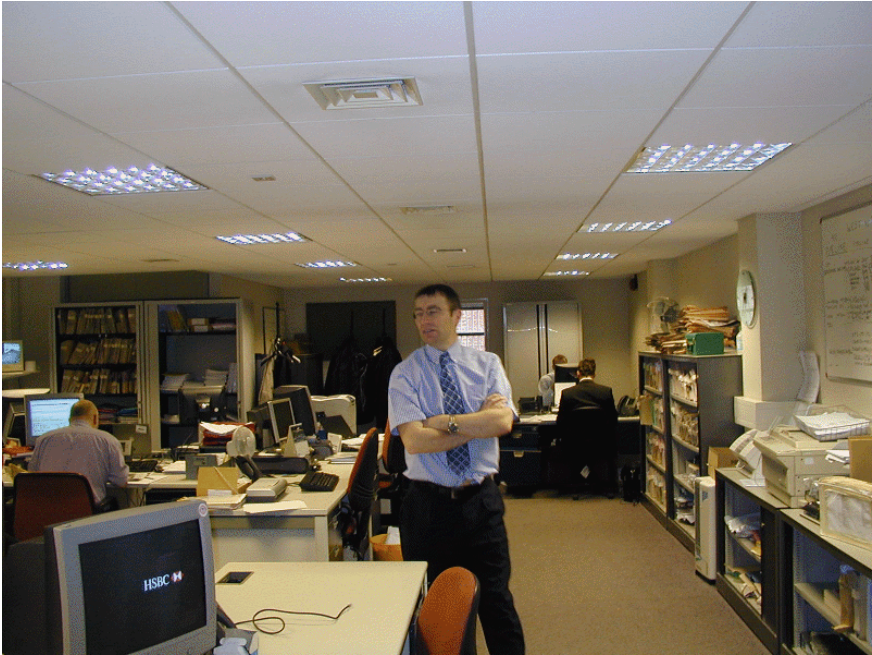
Fig. 23. Second Floor Office. This is the largest of all and once again there is limited natural daylight. Short-sleeved shirts are again in evidence.

To the south side of the building on all floors apart from the basement and ground floor are open plan offices (Figs, 22, 23, and 24), the largest of which is on the second floor. A small area at the southern end of the ground floor provides facilities for servicing the cash point machines located in the outer foyer.

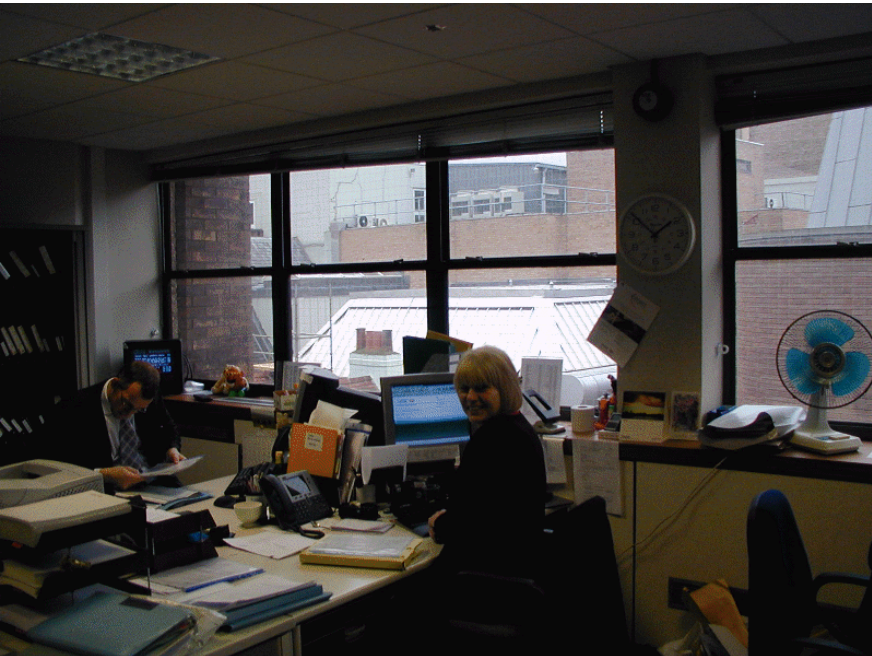
Fig. 24. The third floor office. This is smaller than the second floor and there is much more natural daylight. However, lights near the window were on during visit. A particular problem arises in this office from the glare from the roof of the building opposite seen through the window. When this photograph was taken the sun was not shining directly onto the roof.

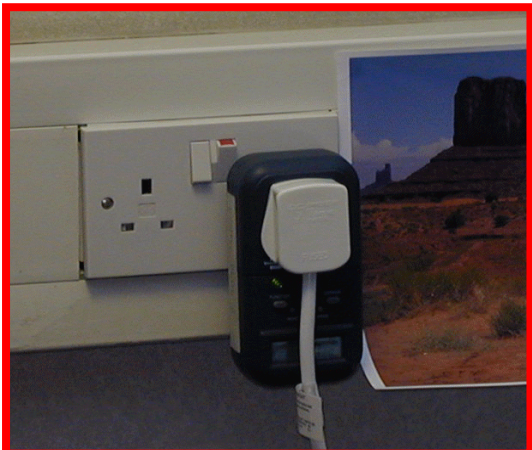
Fig. 25 A cost plug to measure electricity consumption

To ascertain the actual consumption of workstations a cost plug (Fig. 25) was installed on one unit (Fig. 26).

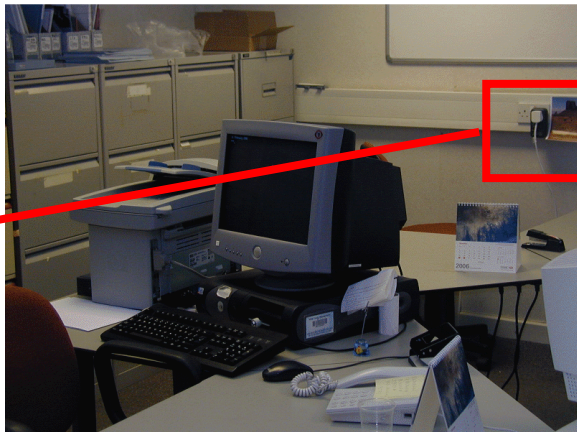
Fig. 26. Work station in First Floor Office under test for electricity consumption

The results from occasional readings over a week indicate that the work station was not always switched off at night (Fig. 27).

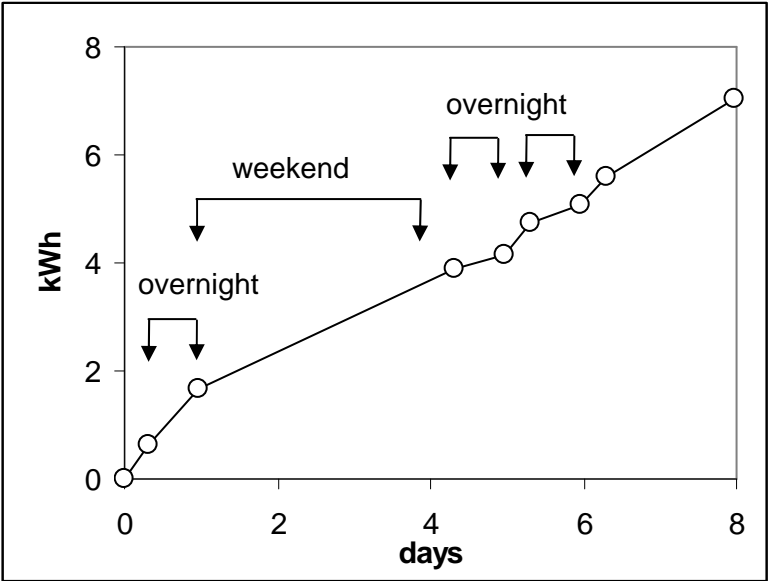
Fig. 27. Energy consumption of a work station over a period of 8 days. On the nights of day 0 – day 1 it is clear that the work station was not switched off. There is also significant use over the weekend. For days 5 and 6 when readings were taken both in the morning and evening, the results show that the computer has been consuming some power over night even when apparently off.

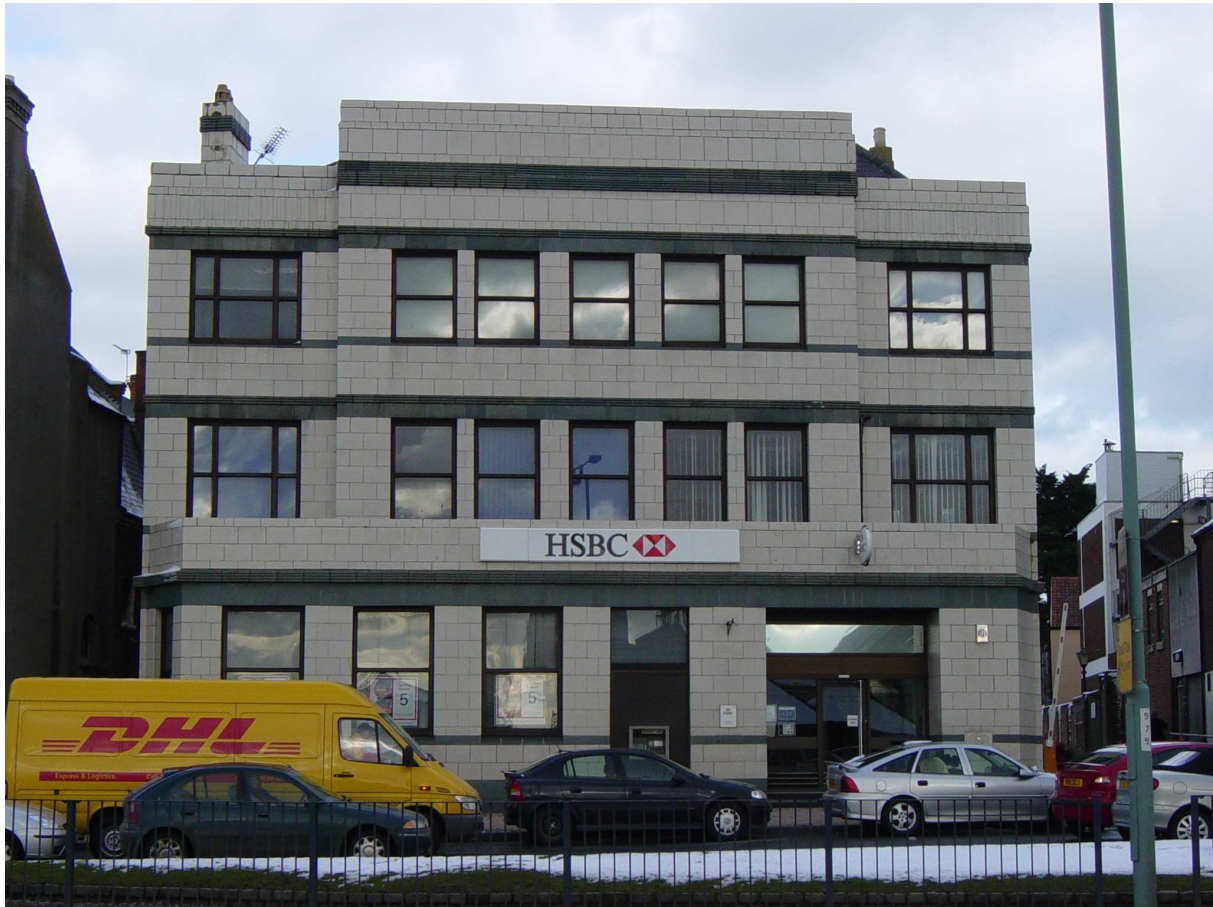
Fig 34. The front of the Great Yarmouth branch.

Originally a 1920s hotel, the building is freehold but now listed due to the art deco tiles. Unfortunately these are now leaking creating damp rooms inside. On-site discussions indicated that extensive investigations have taken place to determine the source of the leaks. It remains unclear to staff on site if the problem is with the tiles themselves or the grouting in between. The building has single glazed windows with aluminium frames. These are draughty. The building consists of four floors including the basement.

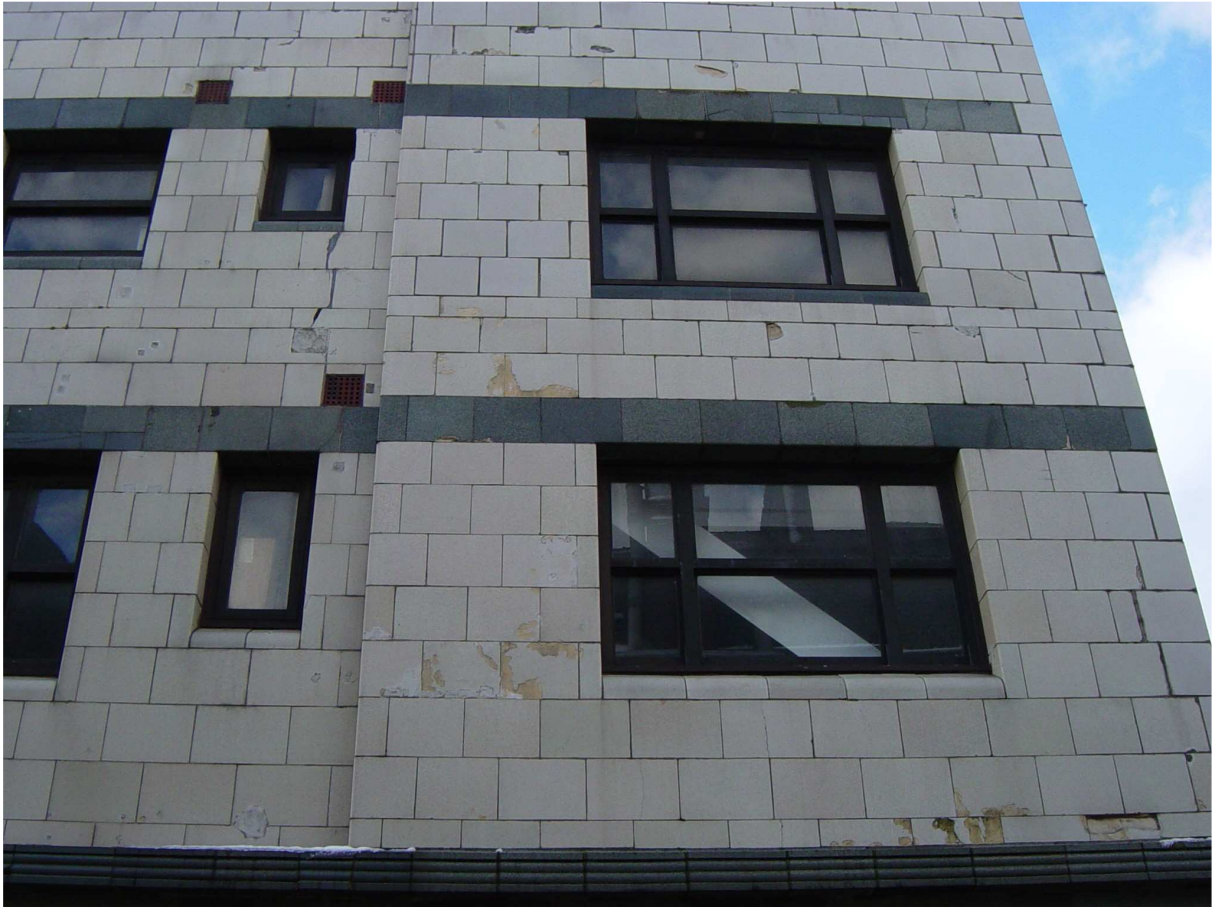
Fig. 35. View of the side of the building showing the problems with the tiles. It was reported that some had fallen off and been cemented back on.

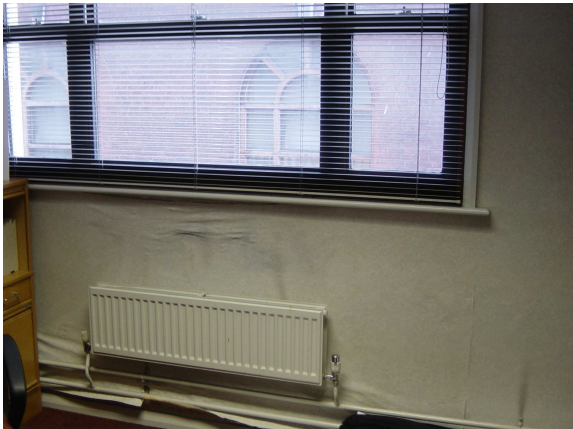
Fig. 36. Dampness on inside of building

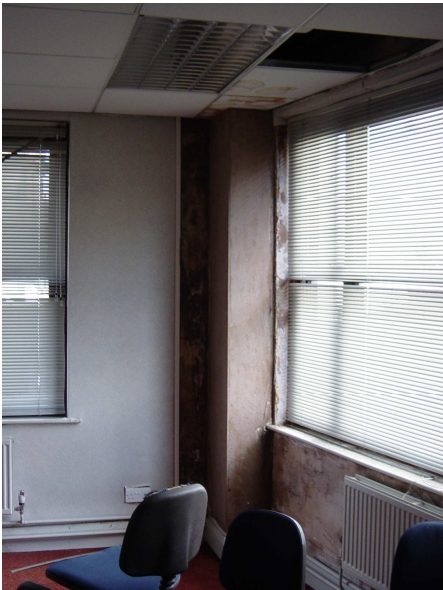
Fig. 37 Room now unusable

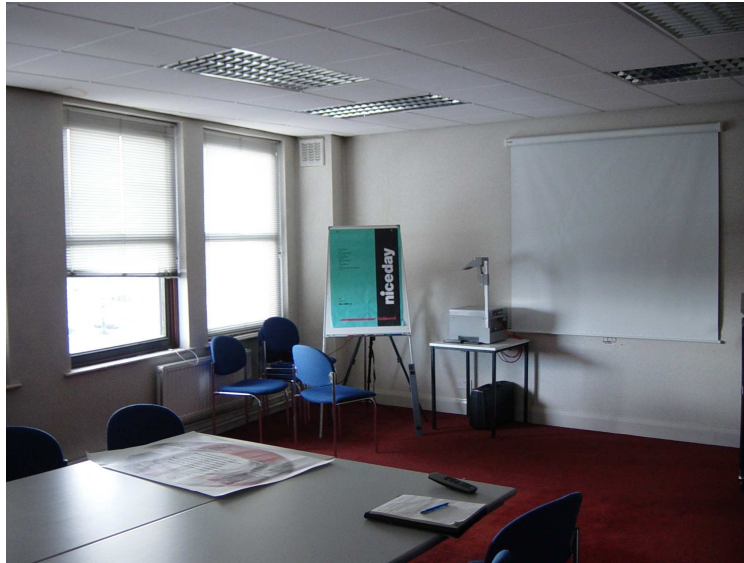
Inside the building this is causing damp walls (Fig. 36). Some attempts to mitigate this have been made by installing false walling over the damp areas. One room has become uninhabitable (Fig. 37). The training room (Fig. 38) on the second floor has outside walls so damp that electrical equipment is plugged into an adjacent corridor and leads trailed into the room for fear of electrical short circuit in the training room itself.

Fig. 38. The training room

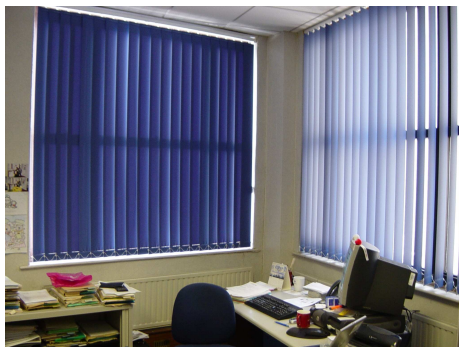
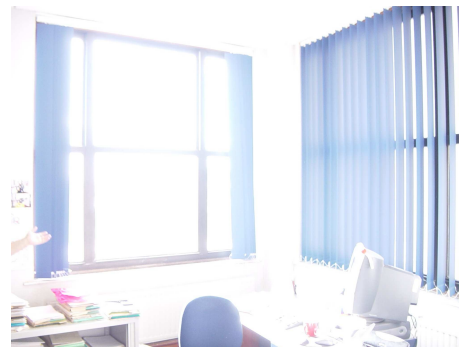
There is a gas fired wet central heating system, possibly installed as part of a previous refurbishment. It seems that this is ineffective in providing even warmth throughout the building as a more modern electric climate control (Mitsubishi) system has also been installed. Some of the controls appear to be handled by Group HQ through a modem connection, whilst others are operated locally. Evidence from the commercial office on Floor 1 indicates that these systems are in conflict; a situation made worse by intense solar gain through large west facing windows covered by dark coloured (and therefore heat absorbing) blinds. Clearly this is having a detrimental effect on staff morale.

Fig. 39 Coloured blinds drawn and open

Fig. 39 shows the difference in glare when the blinds are closed and open. The colour of the blinds was chosen to match the furniture. Had they been a lighter colour more of the heat would have been reflected.

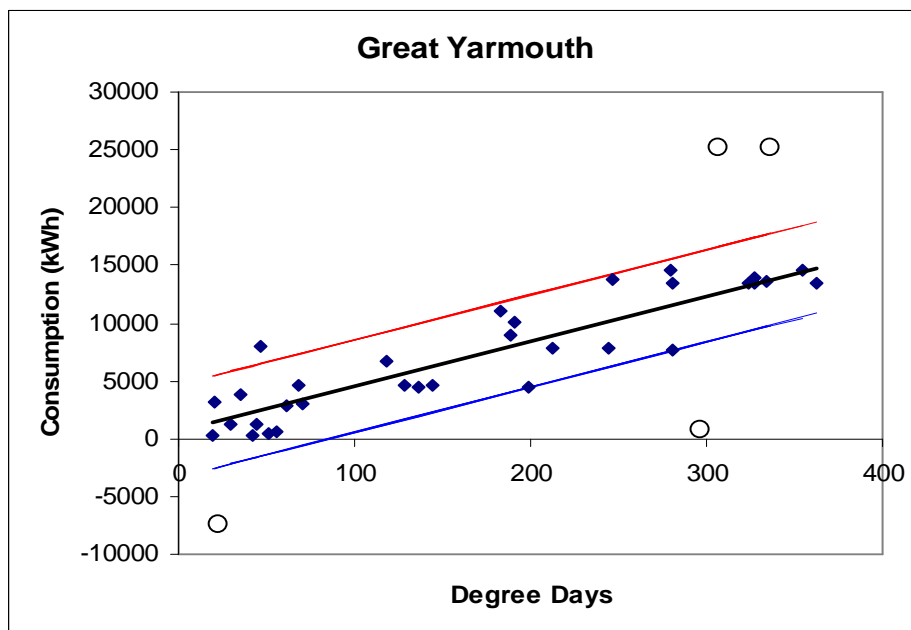
Fig. 42. Relationship between Gas Consumption and Degree Days for Great Yarmouth Branch. Four of the data points, shown as open circles, are clearly somewhat in error.

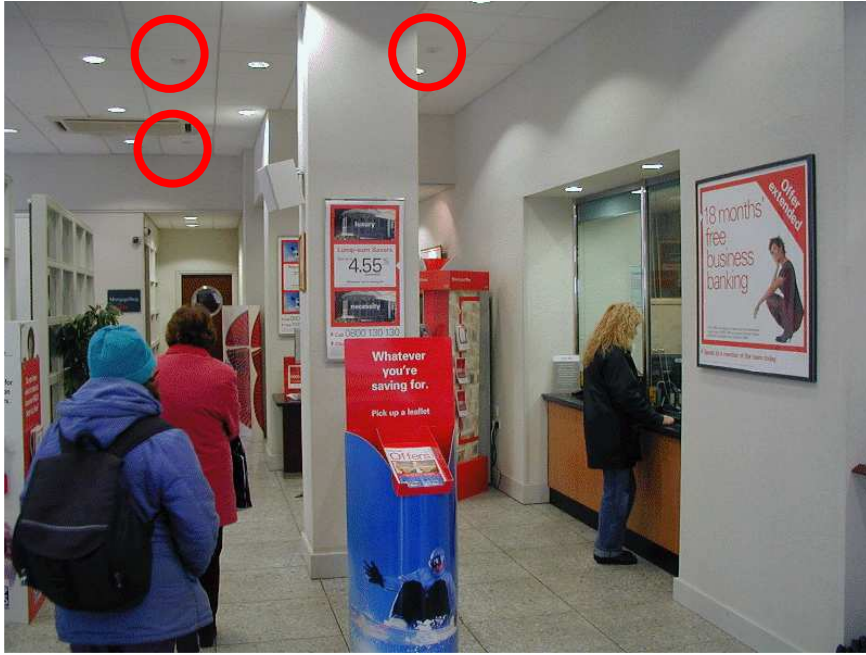
Fig. 47. The main customer area. Notice the spot lights which are unnecessary

In general, most of the lighting was of low energy either as compact fluorescent bulbs or T* fluorescent tubes. However, there were a few spot lights which were unnecessary. Those for display purposes should be replaced by the new CFL spot light equivalents. Many of the overhead lighting units had several tubes in each, and a strategy should be implemented for rewiring to allow restricted numbers of such tubes to be used at any one time. The majority of workstation monitors are of the CRT type and these use considerably more energy than their flat screen equivalents. The programme of replacement should be accelerated. This reduction in energy use will also have the added benefit of a lower requirement for air-conditioning in summer thereby saving more energy and consequential emissions.

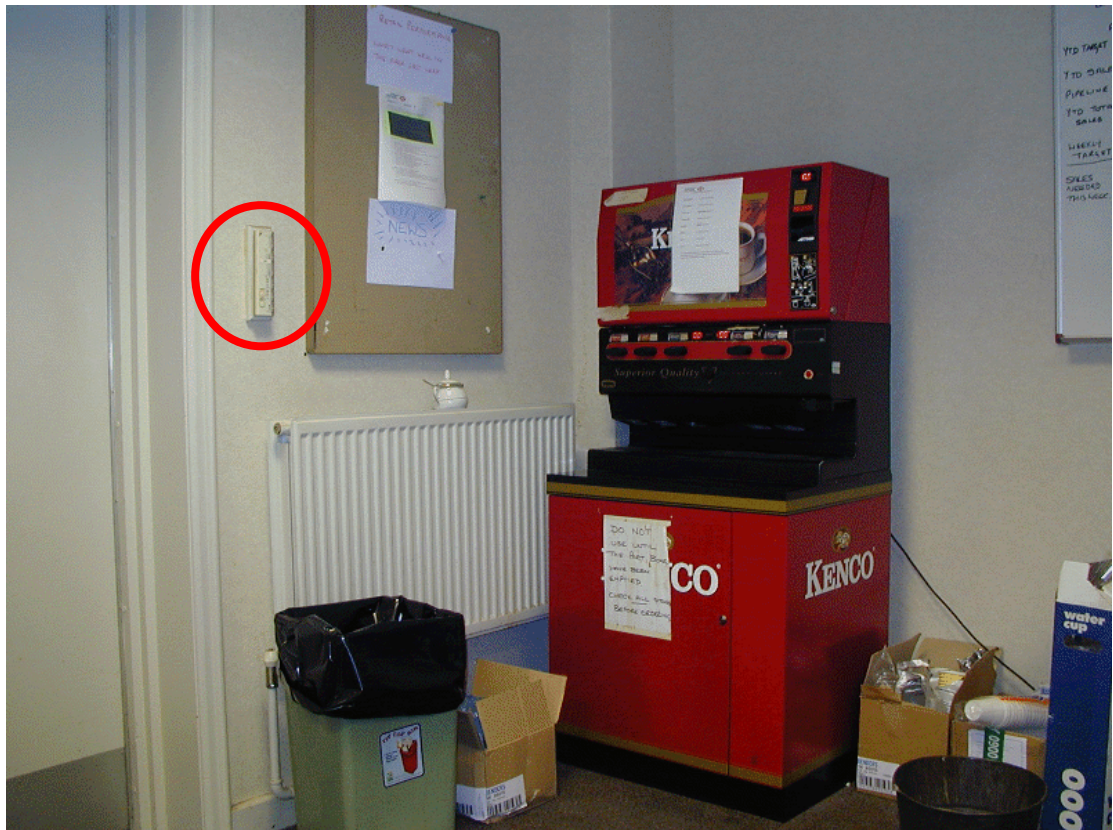
Fig. 50. The corner of the downstairs office. All heating is provided by panel radiators as shown with some having fins. All radiators are equipped with thermostatic valves although some need a little attention. The control for the air-conditioning is shown highlighted by the red circle. This is a confusing unit and few, if any, staff appear aware how to control it.

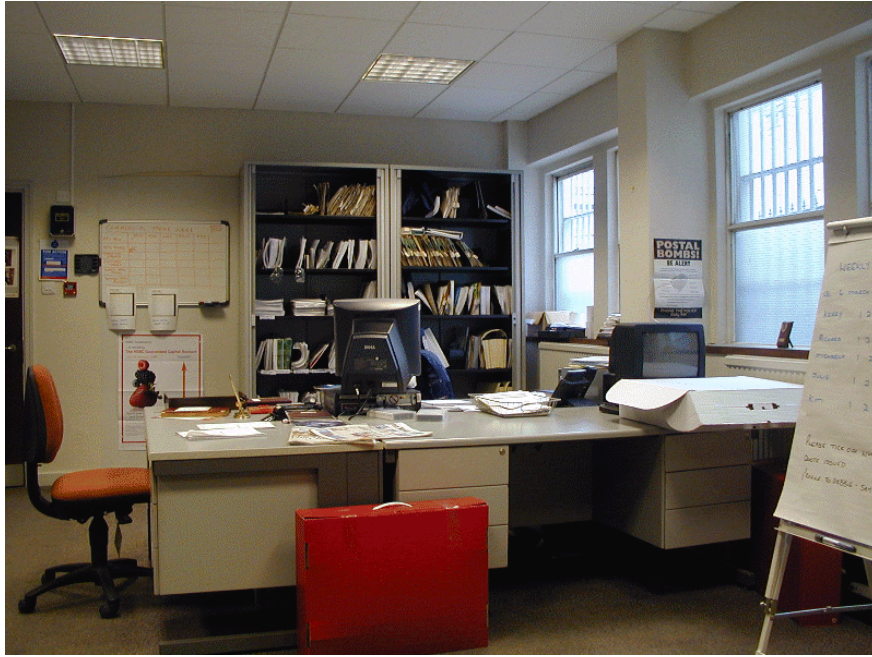
Fig. 51. The ground floor office. Natural daylight is limited in this office and there is little scope for reduced lighting.

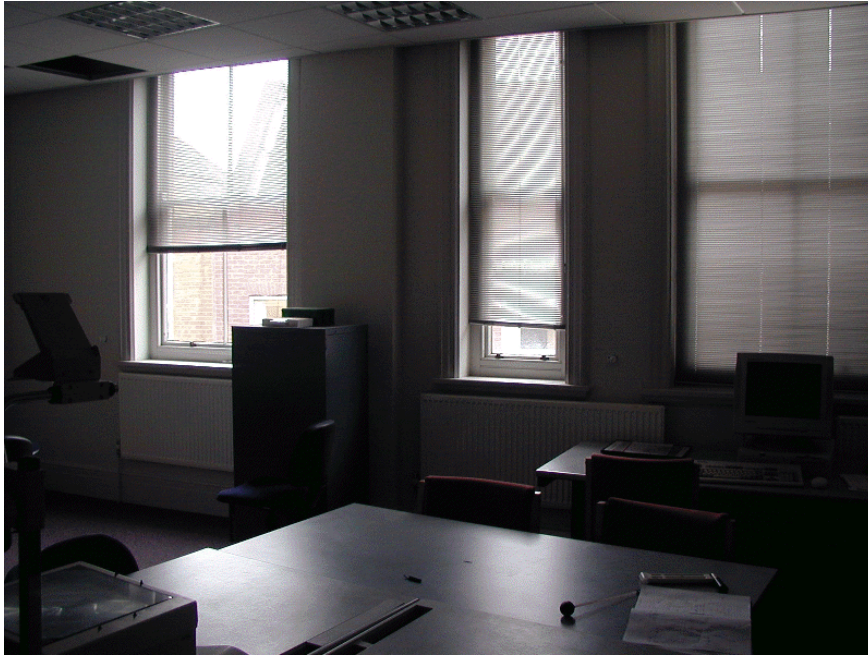
Fig. 53. The conference / training room. This room like most of the other rooms not in use at Kings Lynn had the lights off. The temperature of this room was lower than others as indicated by the wall thermometer (Fig. 54).

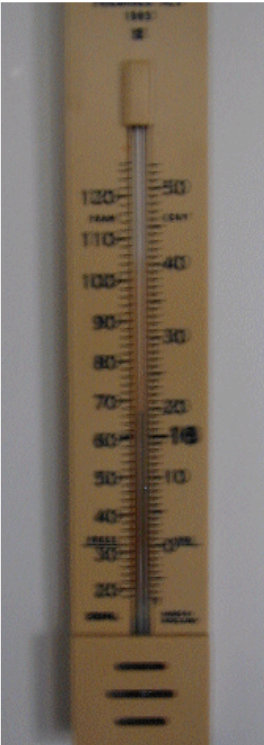
Fig. 54. The thermometer clearly visible on the wall in the conference room – registering 19.5°C. This room was not in use and heating was at a low level.

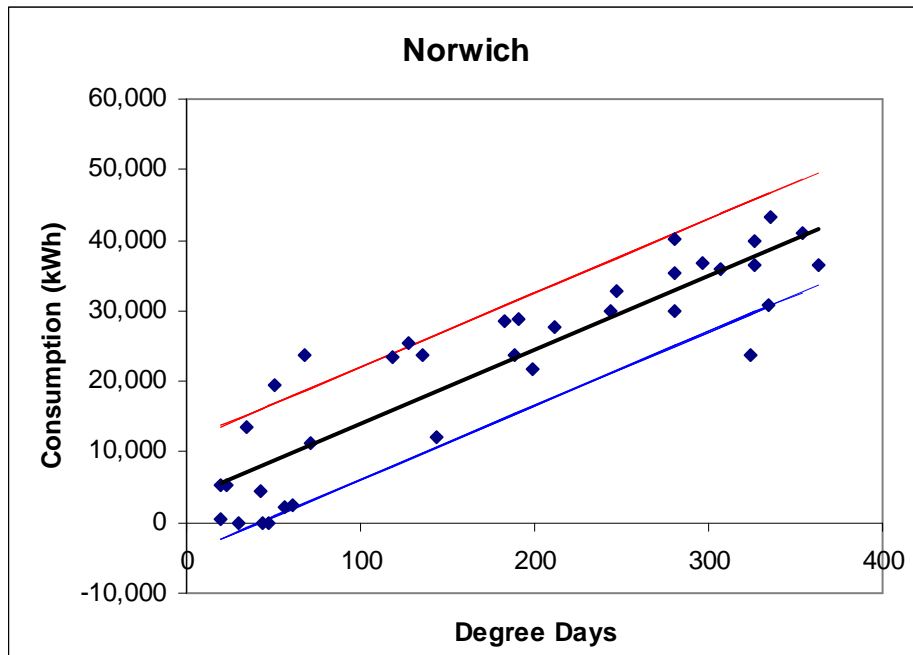
Fig. 60 The plot of gas consumption against Degree Days for Norwich together with a suggested upper and lower limits (± 8000 kWh/month) at which reporting might be required.

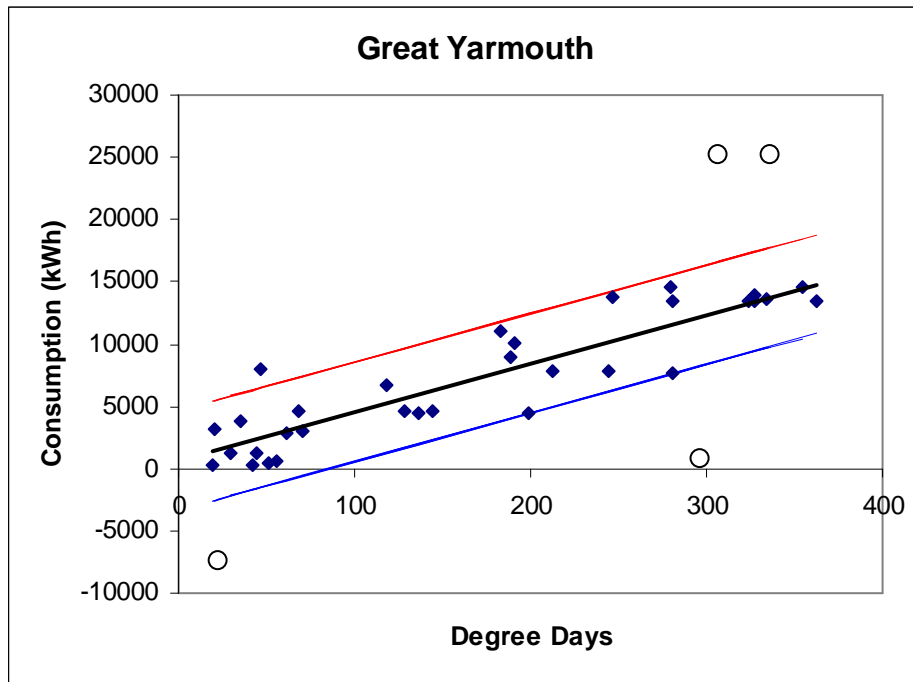
Fig. 61. The plot of gas consumption against Degree Days for Great Yarmouth together with a suggested upper and lower limit (± 4000 kWh/month) at which reporting might be required.

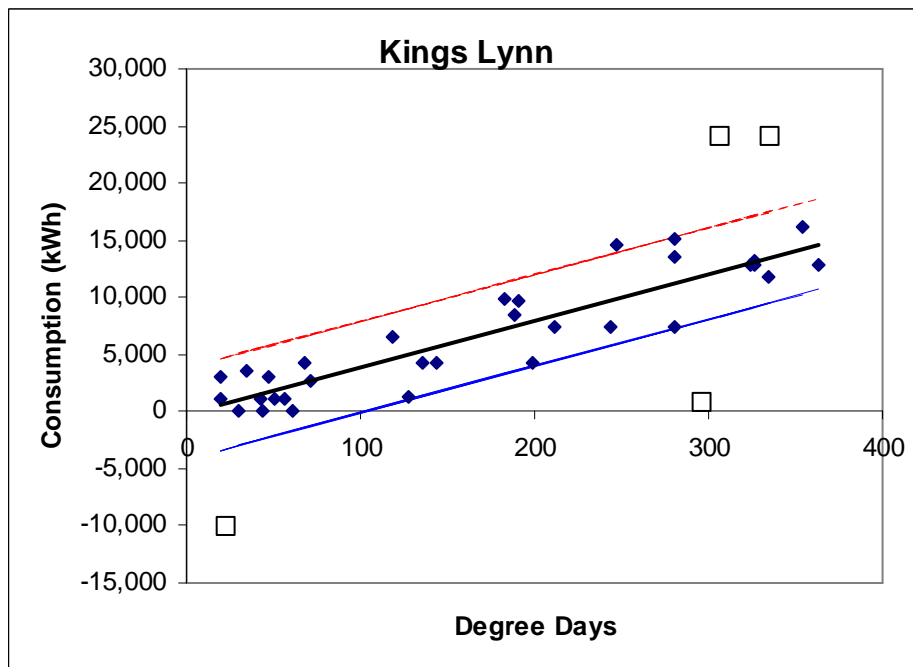
Fig. 62. The plot of gas consumption against Degree Days for Kings Lynn together with a suggested upper and lower limit (± 4000 kWh/month) at which reporting might be required.

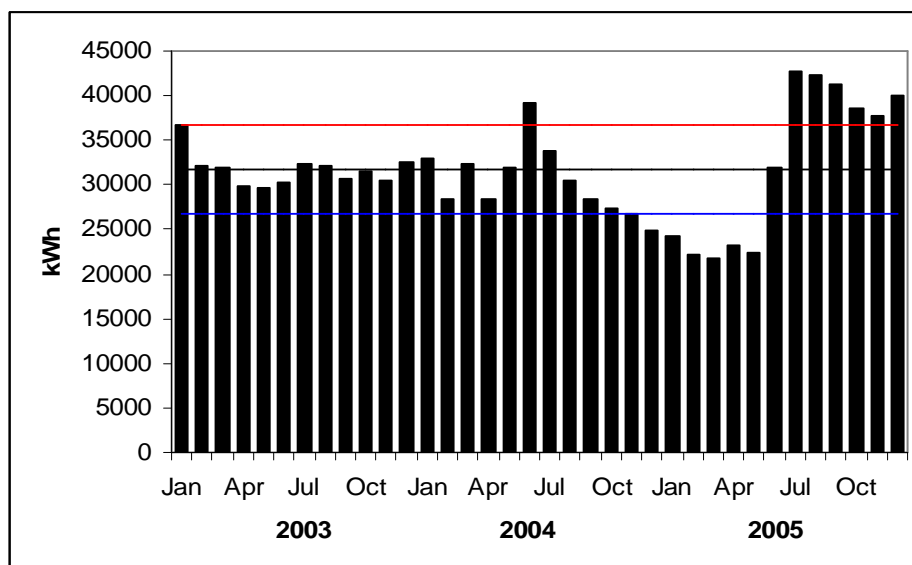
Fig. 63 Electricity data for the Norwich Branch with upper and lower bands at +/- 4000 kWh
