## 6. The Incidents at Fukushima following Earthquake of 11<sup>th</sup> March 2011

This section is based on notes written on a daily basis immediately following the earthquake on 11<sup>th</sup> March 2011. In the week that followed, information was scanty and there was quite some misinformation put out. I aimed to try to pull things together from different sources to explore what might have happened, and indeed much of my analysis did subsequently prove to be a fairly accurate assessment. I continued these reports for 12 days, but which time further information became available. There is now a vast amount of objective data produced on a near daily basis. It is my intention that this section will be completely rewritten over next 2 – 3 months now that most information is now available. Nevertheless this does give a chronological development of the events. The original report which is accessible from the WEBSITE was split into 13 sections. The first 3 sections have been summarised already in additions to section 2.3.5 above. For consistency with the original document the section numbering is as follows – Section 6.4 below refers to section 4 for the original document, section 6.5

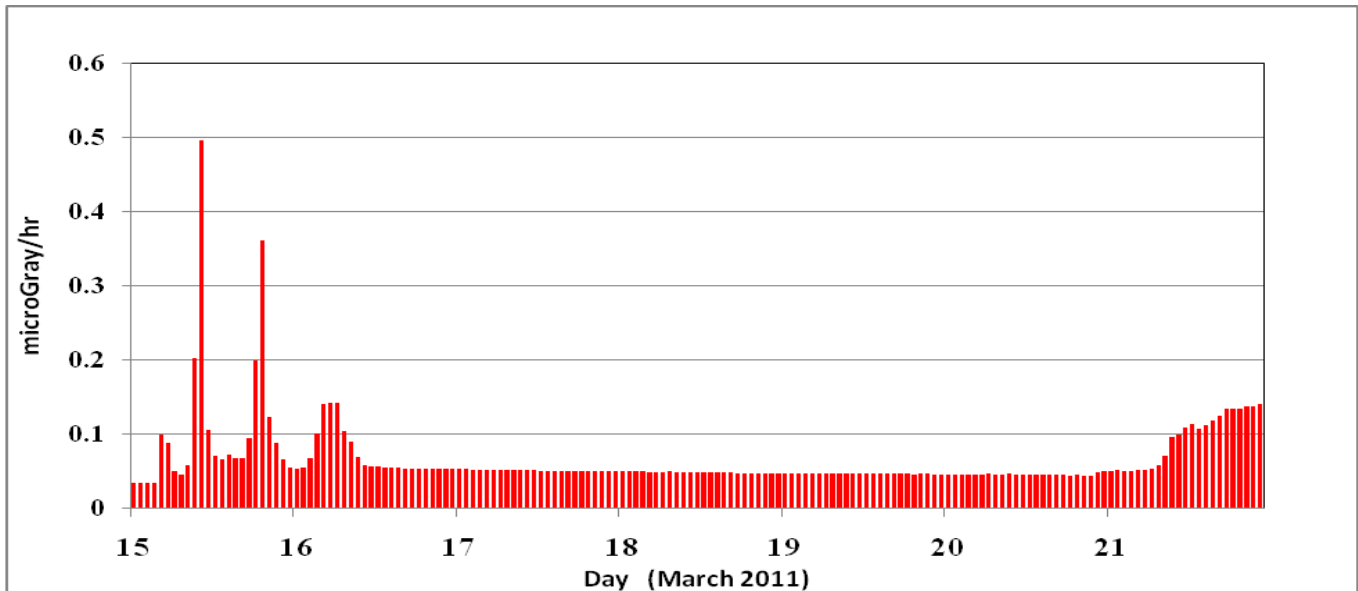
**Figure 13.1** Hourly Radiation data measured at Shin-juku in Tokyo.

The graph in Figure 13.1 shows the values in micrograys as actually measured. Noticeable is the rise in the last 24 hours to around 0.15 Grays per hour – if that level were to continue and the weighting factor is indeed 4, then the annual radiation dose if maintained at this elevated level would be equivalent to less than a single CT scan (approx 5800 microSieverts a year) and also equivalent to a person living in Aberdeen taking a few transatlantic flight a year.

Hourly radiation data has been published on the internet since 15<sup>th</sup> march and a summary is shown in the graph below. Tokyo measure the radiation in microGrays / hr whereas most radiation is measured in micro Sieverts. For beta, gamma, radiation and X-rays the values are the same in both units. However, when alpha radiation is involved there is a weighting factor of 20. The effective weighting factor depends on the proportions of the different radiations, but might well be as high as a factor of 4.
